## HAIL IMPACT TESTING OF MODIFIED BITUMEN ROOF MEMBRANES

Written by: Heidi Mase and Richard Koziol of Wiss, Janney, Elstner Associates, Inc.

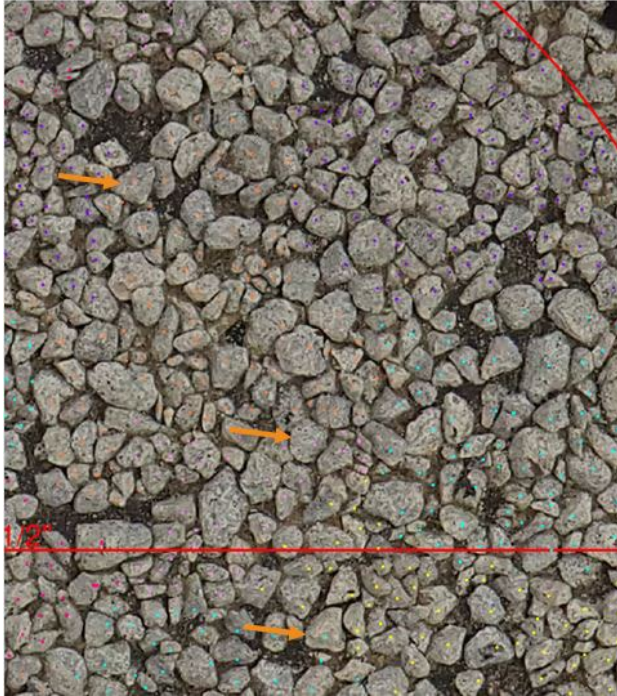
Figure 5. Sample 5-MB-G-1 pre-impact. Orange arrows indicate some differences between the pre-impact and post-impact images.

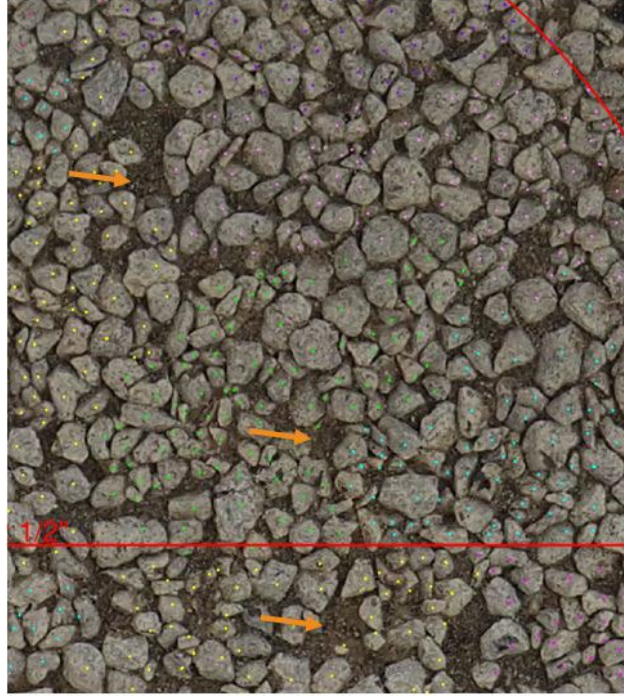
Figure 6. Sample 5-MB-G-1 post-impact. Orange arrows indicate some differences between the pre-impact and post-impact images.

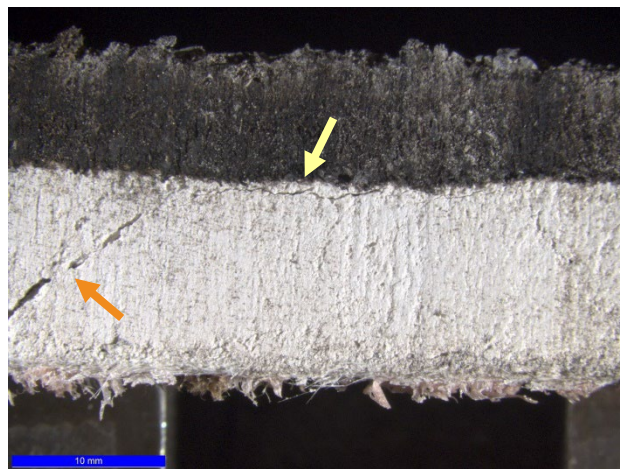
Figure 9. Cross-section of 10-year-old gypsum cover board sample. Note separation of facer from gypsum (yellow arrow) and radial crack throughout thickness of gypsum (orange arrow).

- The impacts did not fracture the membrane reinforcement in any of the samples.
- Cracking of the gypsum cover board was observed at the impact site in all gypsum cover board samples that were tested. The impacts also caused cover board facer separation from the gypsum core at the impact sites in two thirds of the gypsum cover board samples. The wood fiber cover board samples were visually unaffected by the impacts.

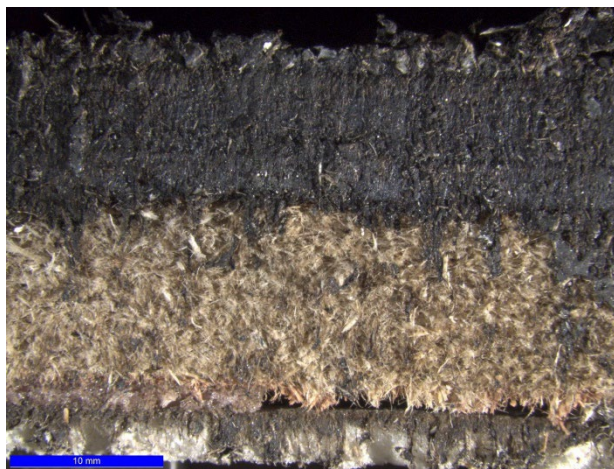
Figure 10. Cross-section of new wood fiber cover board sample. Note that no separations are visible.

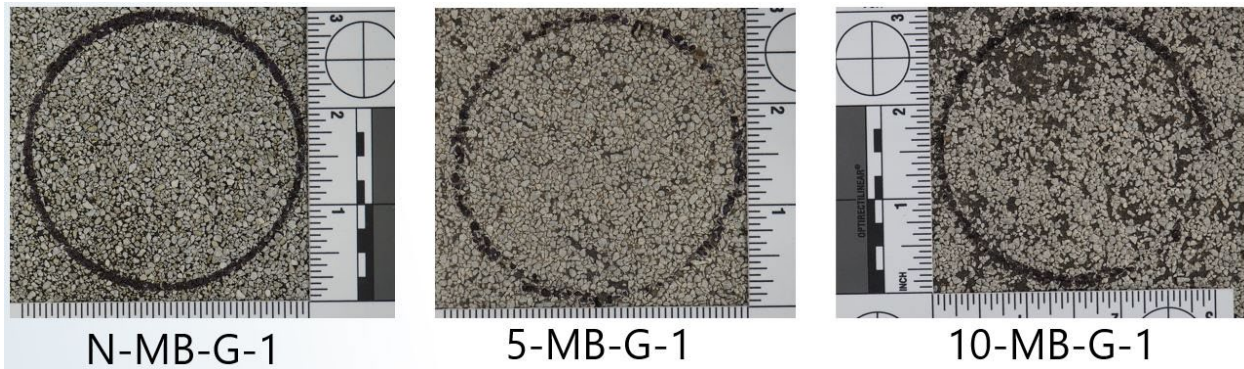
- In general, regardless of cover board type or impact, the quantity of granules on the membranes decreased with age, while the exposed bitumen area generally increased with membrane age. There was a larger increase in exposed bitumen area between five- and ten-year-old membranes than there was between new and five-year-old membranes (Figure 11).

Figure 11. Comparison of new, five, and ten-year-old membranes over gypsum cover board.
